## IP X7 Test

## IK Test - Test according to IEC EN 62262

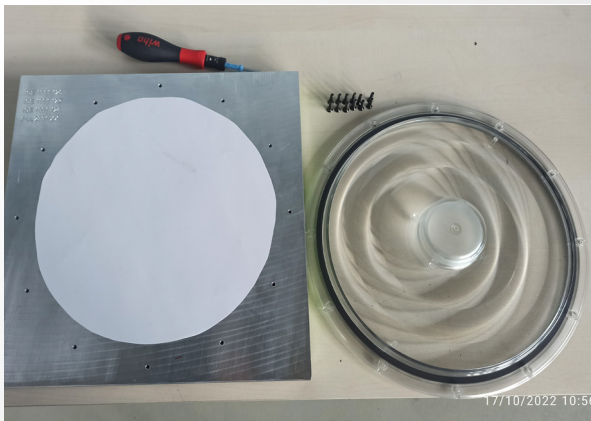
PLL2331xx Assembled

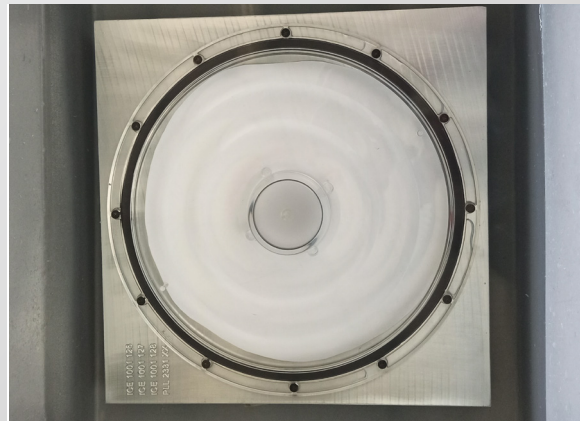
Testing immersion

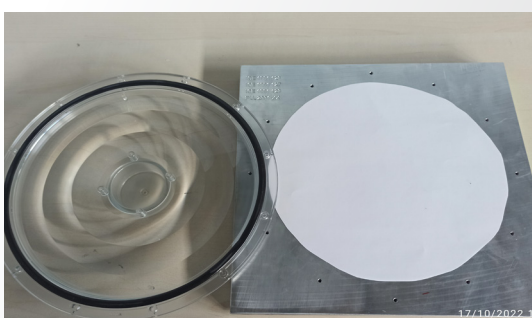
As shown in the photo, the test paper sheet is completely dry after disassembling the system.

Based on the water penetration resistance test, we can say that the polyurethane deposit ring 2 filed without primer proved to be fit for purpose.

**The test paper sheet is dry.**

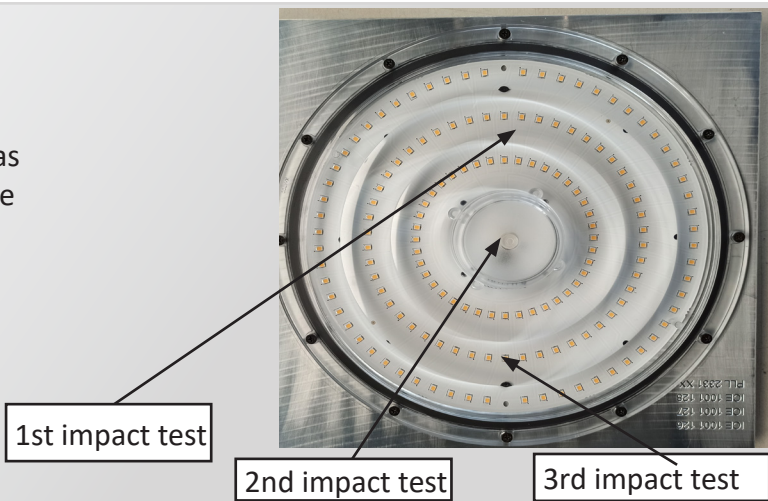
The components resulted physically intact.

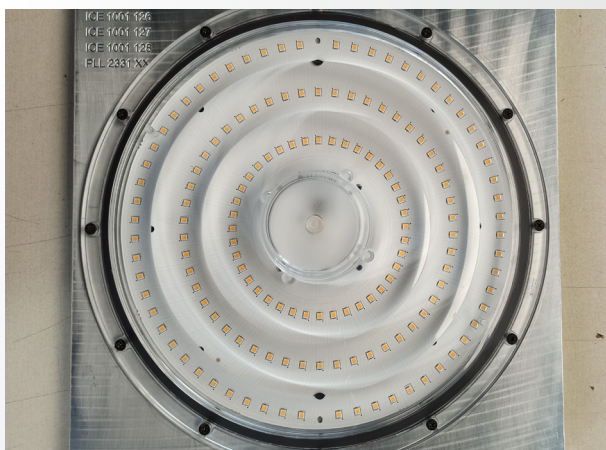
After testing, a final visual inspection was performed. The result was positive (view photo).
